## **The Influence of Organization Culture on Aviation Safety – A Case Study of a United States Navy FA-18 Landing Mishap**

Peter J. Kind

*University of Tennessee - Knoxville*

I am submitting herewith a thesis written by Peter J. Kind entitled "The Influence of Organization Culture on Aviation Safety – A Case Study of a United States Navy FA-18 Landing Mishap." I have examined the final electronic copy of this thesis for form and content and recommend that it be accepted in partial fulfillment of the requirements for the degree of Master of Science, with a major in Aviation Systems.

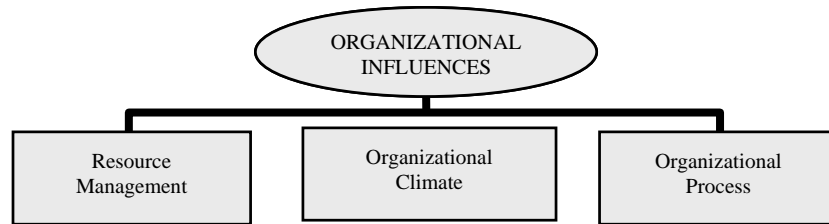
Figure 7. Organization Influences Classification (Naval Safety Center).

The final barrier or “slice” in the HFACS model is Organizational Influences. Decisions of upper-level management directly affect supervisory practices and conditions as well as the actions of individual operators. These influences usually represent the most latent conditions and as such may be in place well before the mishap. These failures occur in areas relating to resource management, climate, or processes as shown in figure 7.
